# Hydraulic Fracturing Tests in the Laboratory with Image- and Acoustic Emission Monitoring

Bruno Gonçalves da Silva, Bing Li, Zabihallah Moradian,  
John Germaine, Herbert Einstein

**ARMA Symposium 2015 – San Francisco**

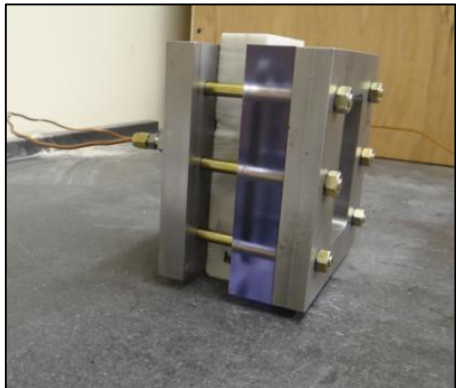
- Water Pressure Device

- Designed to withstand 10 MPa of water pressure

- The water pressure device and test setup developed at MIT are capable of simultaneously applying water pressure in pre-existing flaws and vertical load on rock specimens
- The test setup includes visual and acoustic emission monitoring
- The test setup has been successfully used in several tests performed on granite specimens

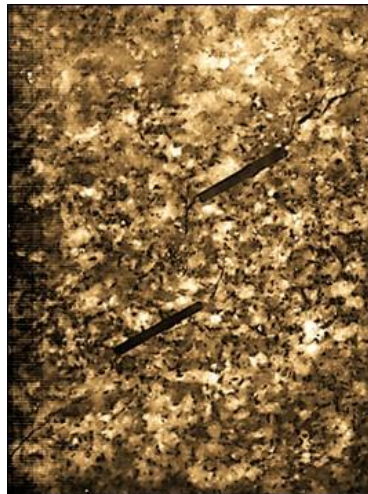
HSV Frame: Sketch 9  
showing visible cracking

$p_{\text{water}}$ : 4.90 MPa

$\sigma_{\text{vertical}}$ : 0.00 MPa

- High-resolution images captured every 5 or 2 seconds throughout the test
- High-Speed Video (HSV) Frames capturing approximately last 1.613 sec of the test

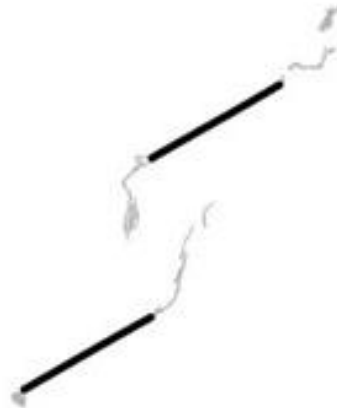
**Sketch 3** (From High-Res.)

Development of “white patching”  
(micro-cracking)
